Board Room

Location: Directly adjoining the south end of the main lobby.

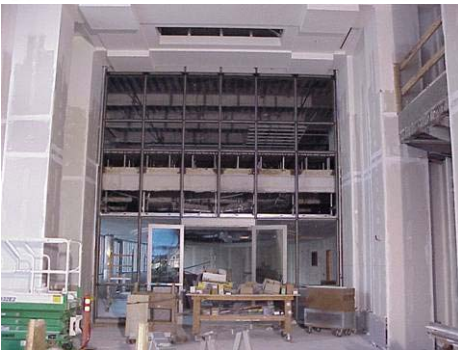
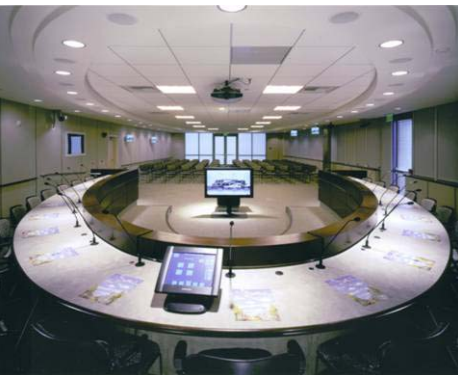
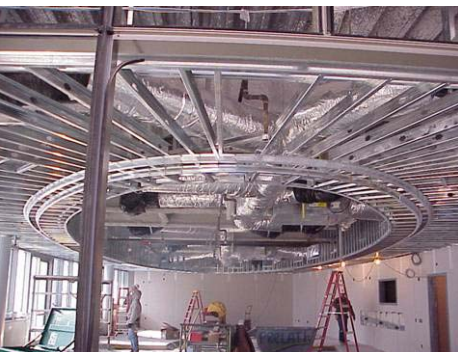
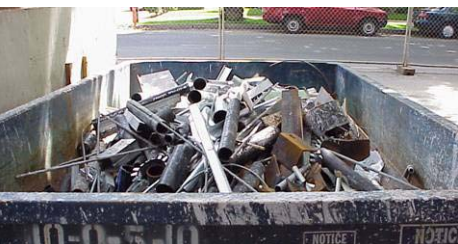
The unfinished lobby and board room provided an opportunity to view the fundamental differences between a conventional overhead HVAC system and an Underfloor Air Distribution (UFAD) system. The second floor UFAD system can be seen above the beam spanning the board room entrance. Only the first floor uses a conventional HVAC system.

Acoustical requirements necessitated an integrated design approach to mitigate ground level exterior noise and assimilate with the state-of-the-art audio/video system. The exterior skin contractor provided dual-paned insulated glass; the mechanical contractor's design minimizes fan-cycle noise; architects selected ceiling tiles for high acoustical absorption values; acousticians were consulted to determine metal stud spacing in the ceilings and walls to reduce noise reverberation; the contractor filled the wall cavities between the framing with acoustical insulation; and fabric-wrapped acoustical wall panels line the room.
